MARINE SAFETY ALERT

Safety Alert 04-22

VERIFY GATEWAY HANDHOLD ARRANGEMENTS **Incorrect Terminations Can Lead to Marine Casualties**

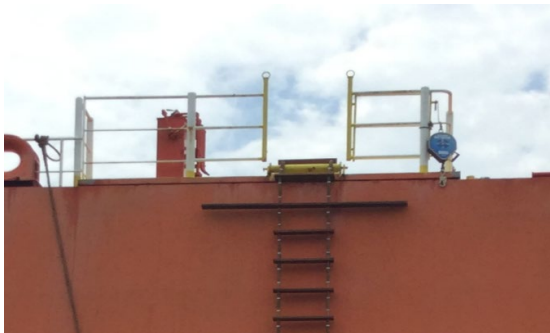
Figure 2: Gap in handholds appear to accommodate spreader.

The Coast Guard observed that the abrupt termination of the handholds above the vessel structure appeared to be a modification that was completed to accommodate the length of the pilot ladder spreader during deployment and retrieval of the pilot ladder. The modification made it possible to retrieve the pilot ladder without having to lift the spreader up and over the vessel's railings (Figure 2).
