## **MARINE SAFETY ALERT**

Safety Alert 09-22

## **HIDDEN CORROSION ON DECK FITTINGS CAN CAUSE DANGEROUS FAILURES**

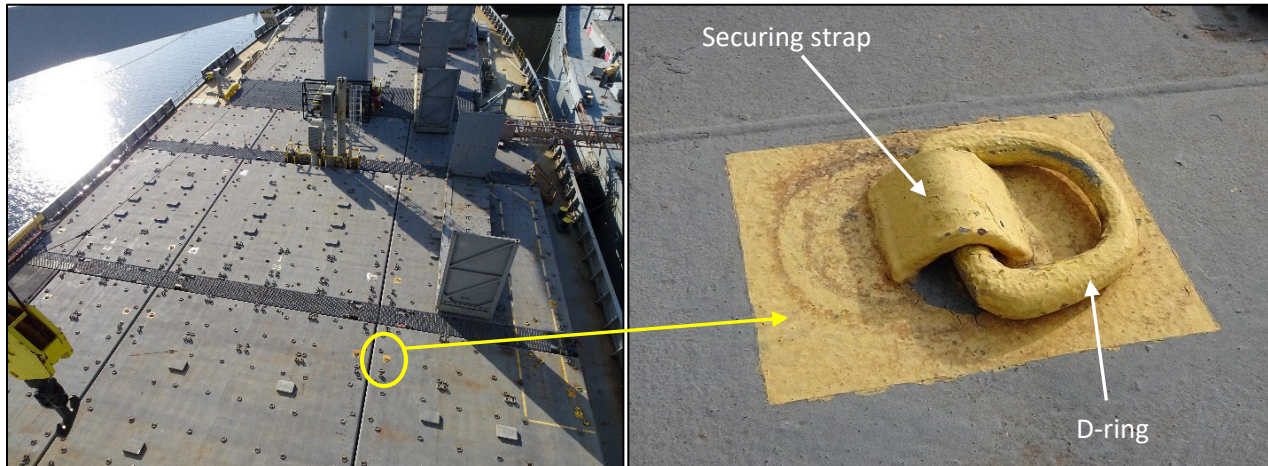
While positioning a removable hatch cover on the vessel (Figures 1 and 2), three of the four D-ring securing straps failed (Figures 3 and 4), causing an uncontrolled snap-back of the lifting sling assembly that struck the crewmember in the head. The three fractured securing straps showed similar failures with a significant amount of corrosion beneath the paint and on the underside of the straps. It is likely that just one D-ring failed initially, which would have instantly doubled the load on the two adjacent corner D-rings, both of which were apparently weakened and subsequently failed.

Figure 1. Deck Configuration

Figure 2. Example D-Ring Configuration

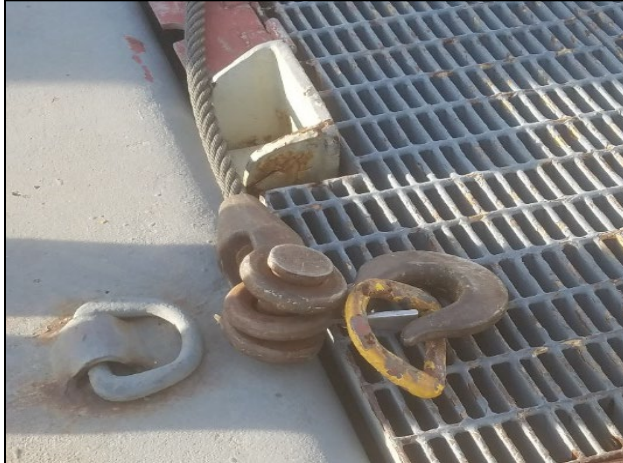
After the incident, the Coast Guard verified that the arrangement of the hatch cover lifting points were in accordance with all available drawings and design schematics. There were no records of any pull-tests or other testing conducted on these lifting points since their installation in the mid-1980s. There were also no records of any D-ring replacements, indicating that these have likely been in an exterior weather deck environment for several decades. Although there are requirements

Figure 3. Separated D-Ring

- Immediately identify high-risk D-rings and similar lifting-point fittings. High risk factors include: Age, weather exposure, and lifting load. These factors will cumulatively cause corrosion losses on the fitting, increasing its stress and fatigue vulnerability during each lifting cycle.
- Thoroughly inspect all high-risk lifting points for damage, hidden corrosion, and wastage. Audio gauging, pull-testing, or even replacement may be appropriate.
- Consult with the manufacturer's instructions to ensure safe lifting limits are in place and that the effects of service life are considered in their determination.
- Establish a maintenance schedule for periodically inspecting all lifting points and audio gauging or testing any fittings as they age into high-risk status.

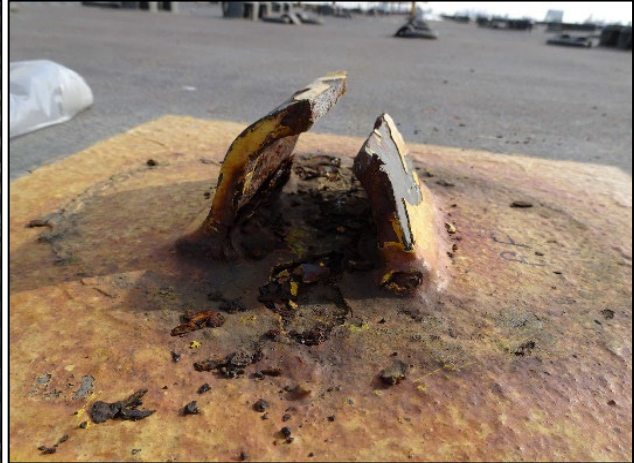
Figure 4. Failed Securing Strap
