UNITED STATES COAST GUARD

MARINE SAFETY ALERT

June 1, 2023 Washington, DC Safety Alert 07-23

CRITICAL INSIGHT FROM ONGOING INVESTIGATIONS INTO SMALL PASSENGER VESSEL FIRES

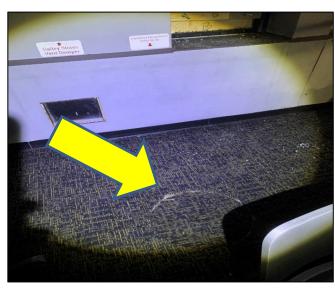
Figure 3: Escape hatch (yellow arrow).

Engine Room Escape Hatch Coverings: In one of the fires, firefighters were unable to locate the engine room escape hatch on the main deck of the vessel. Evidence in the other fire also indicated that circular hatches in the main deck were covered with the same patterned carpet, making the location hard to distinguish. While regulations do not require additional marking, there were no additional markings on the deck in the vicinity of the hatches to allow passengers, crews, and potential emergency responders to rapidly identify the location of the hatches. Hazard tape or other floor marking tapes are recommended to clearly delineate the location of the hatch.
